# **Attachment 4**

Generally Agreed Backfill Design

PROJECT: Bromelton North  
 CLIENT: Neilsens Quality Gravels Pty Ltd

TITLE: Backfill Design - Option 1  
 SCALE: 1:2,000  
 DRAWING NUMBER: 740.DRG.473  
 REVISION: 1  
 DATE: 17 August 2023  
 DRAWN: JHV  
 CHECKED: RH  
 DATUM: HORIZONTAL / VERTICAL / ZONE  
 GDA94 / MGA / AHD / 56

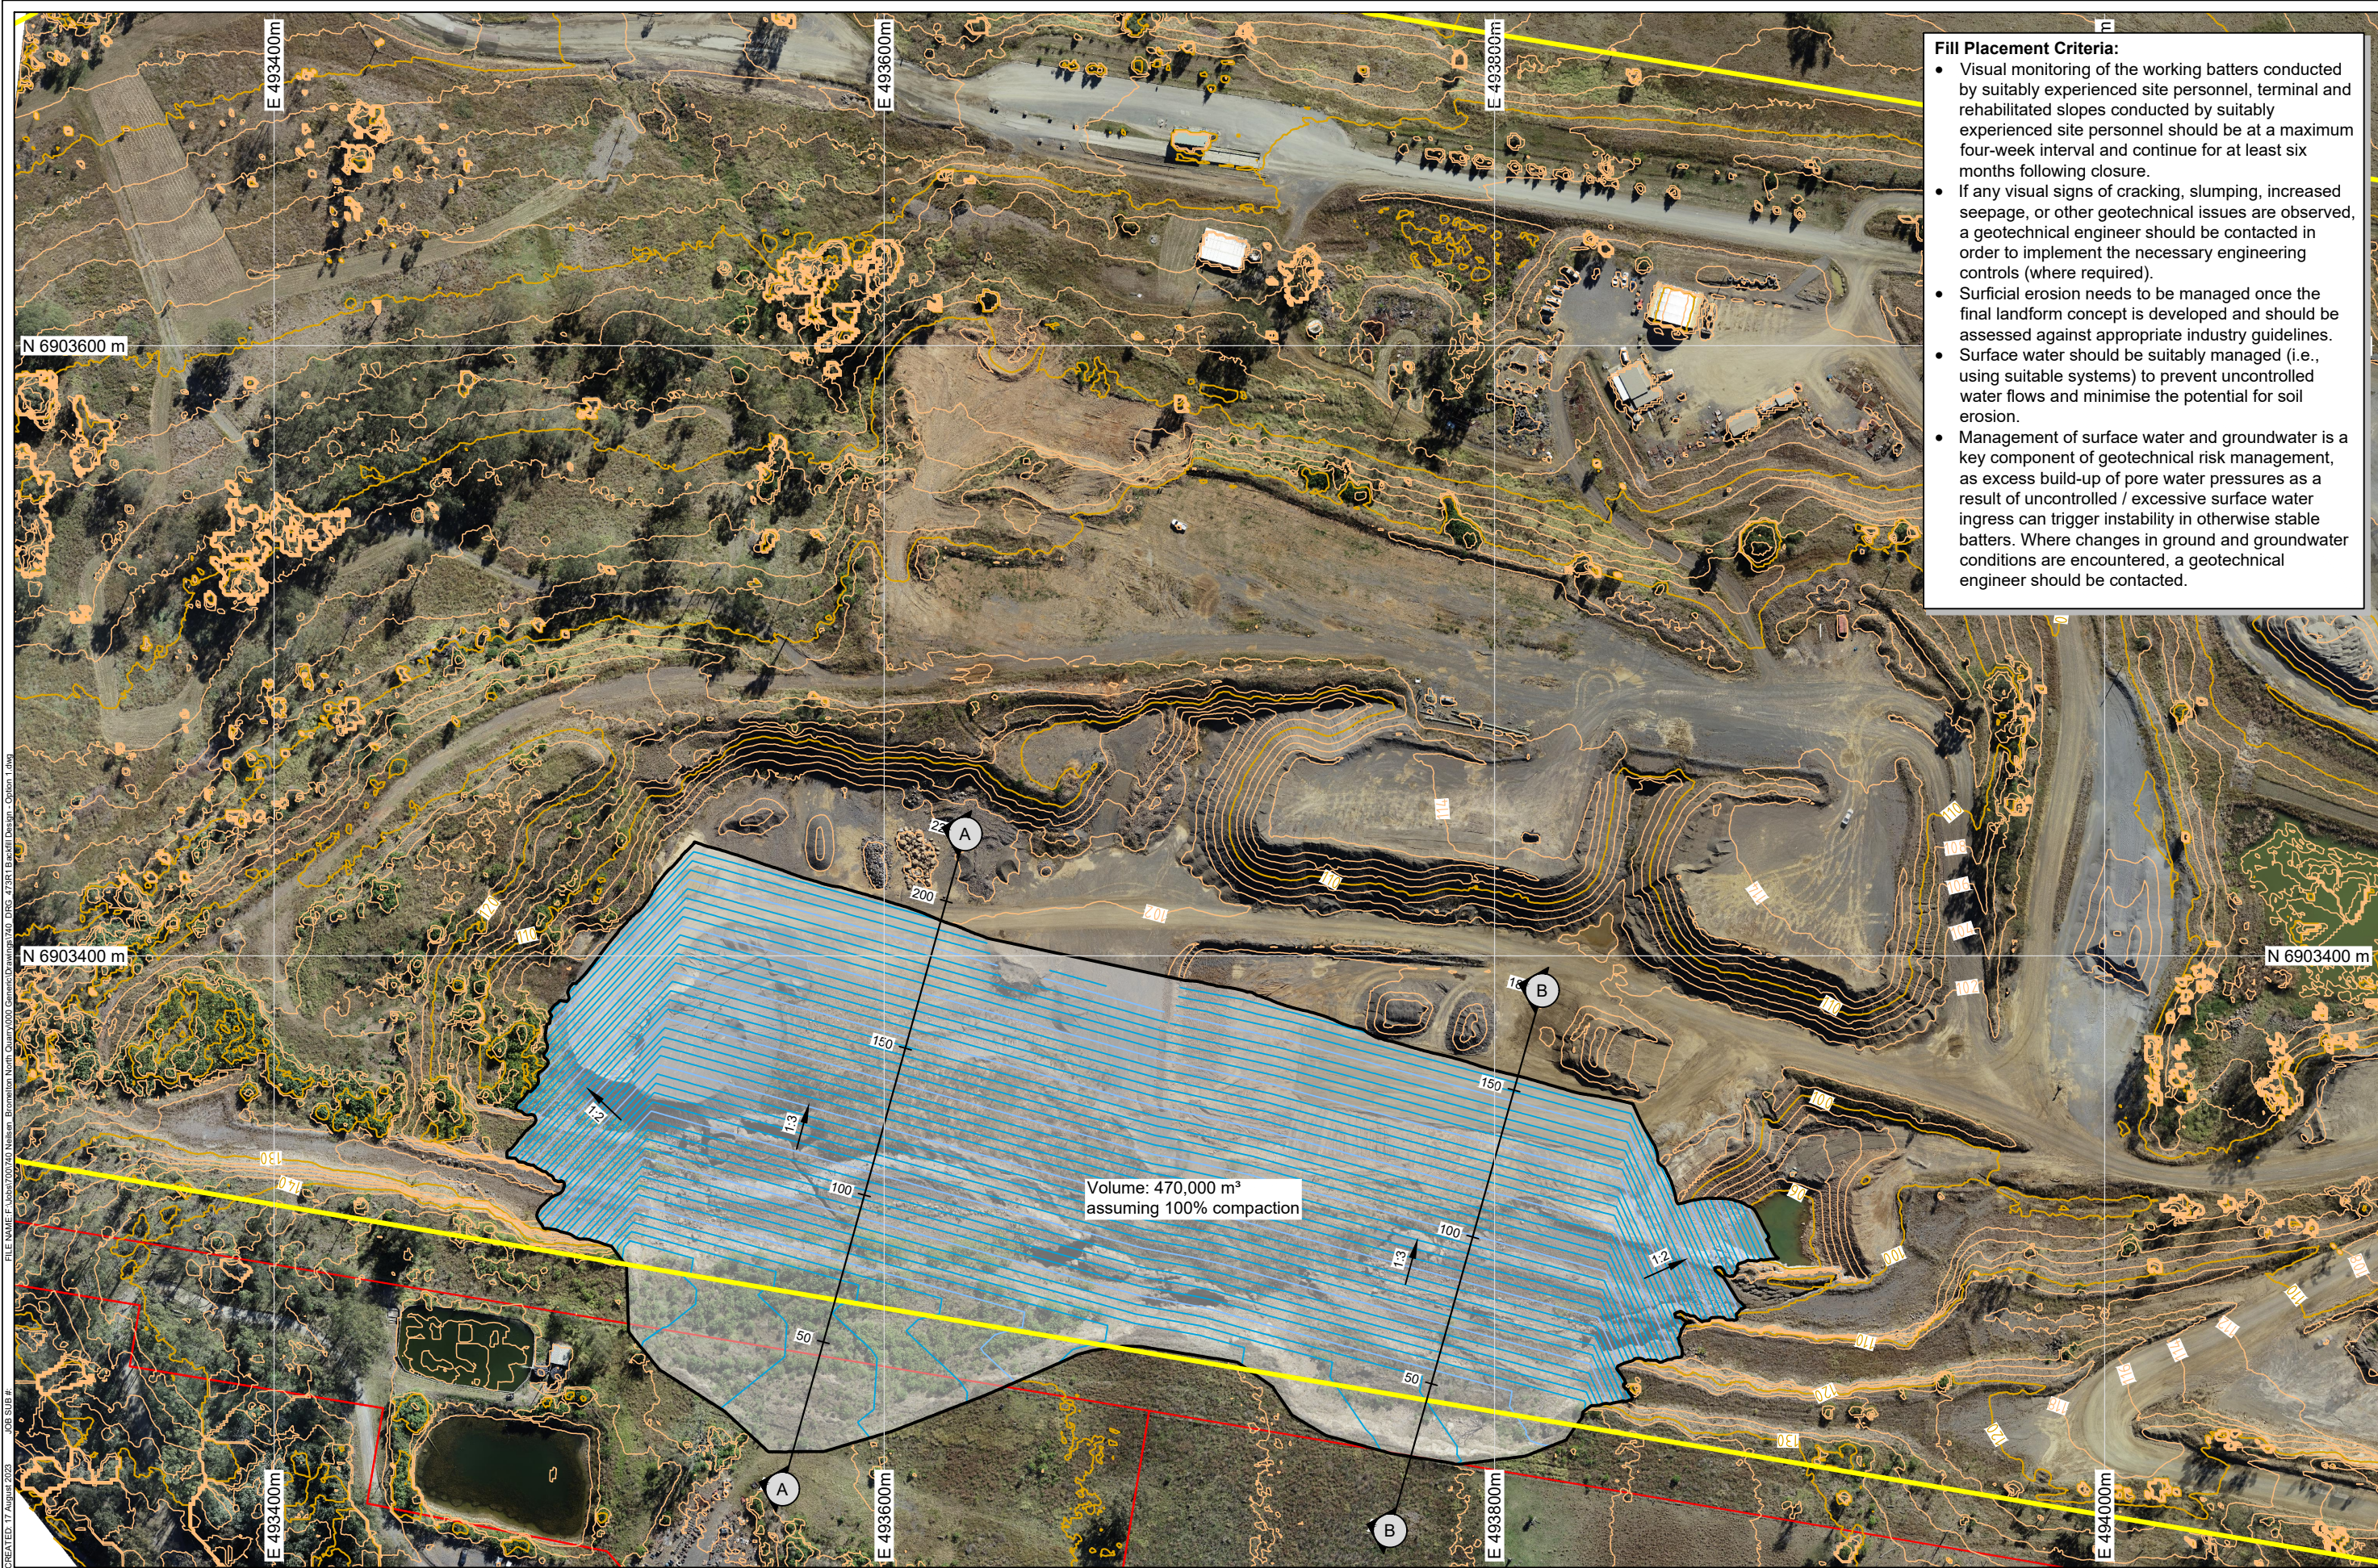
- Fill Placement Criteria:**
- Visual monitoring of the working batters conducted by suitably experienced site personnel, terminal and rehabilitated slopes conducted by suitably experienced site personnel should be at a maximum four-week interval and continue for at least six months following closure.

- If any visual signs of cracking, slumping, increased seepage, or other geotechnical issues are observed, a geotechnical engineer should be contacted in order to implement the necessary engineering controls (where required).

- Surficial erosion needs to be managed once the final landform concept is developed and should be assessed against appropriate industry guidelines.
  - Surface water should be suitably managed (i.e., using suitable systems) to prevent uncontrolled water flows and minimise the potential for soil erosion.

- Management of surface water and groundwater is a key component of geotechnical risk management, as excess build-up of pore water pressures as a result of uncontrolled / excessive surface water ingress can trigger instability in otherwise stable batters. Where changes in ground and groundwater conditions are encountered, a geotechnical engineer should be contacted.
