4.3 Conservation significant flora

Fitzroy to Gladstone Pipeline Baseline Terrestrial and Aquatic Ecology Technical Report Figure 4-3b High-risk Flora Survey Trigger Mapping and Historical Records Within the SGIC SDA Desktop Search Extent 000-G-MAP-2412 Version:2 Date:2022/09/12

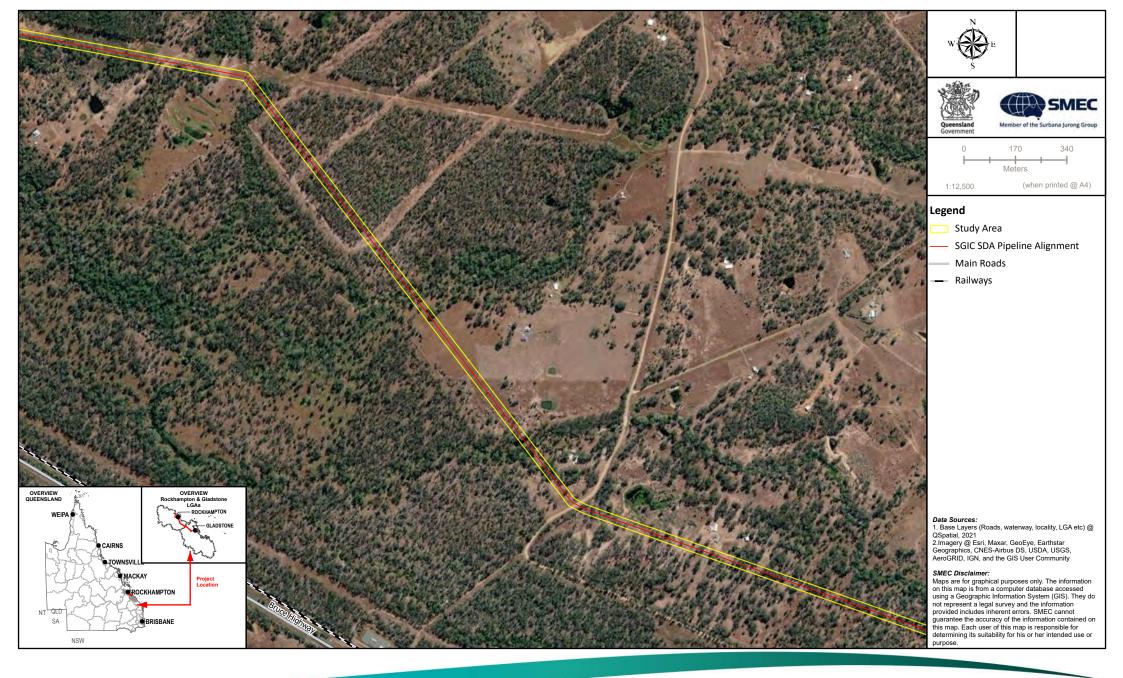
Two high-risk flora trigger areas are intersected by the SGIC SDA pipeline alignment, both within the vicinity of Twelve Mile Road (Figure 4-3). Additional high-risk flora trigger areas are mapped within the broader desktop search extent, predominantly between Raglan and Bajool (Appendix A).

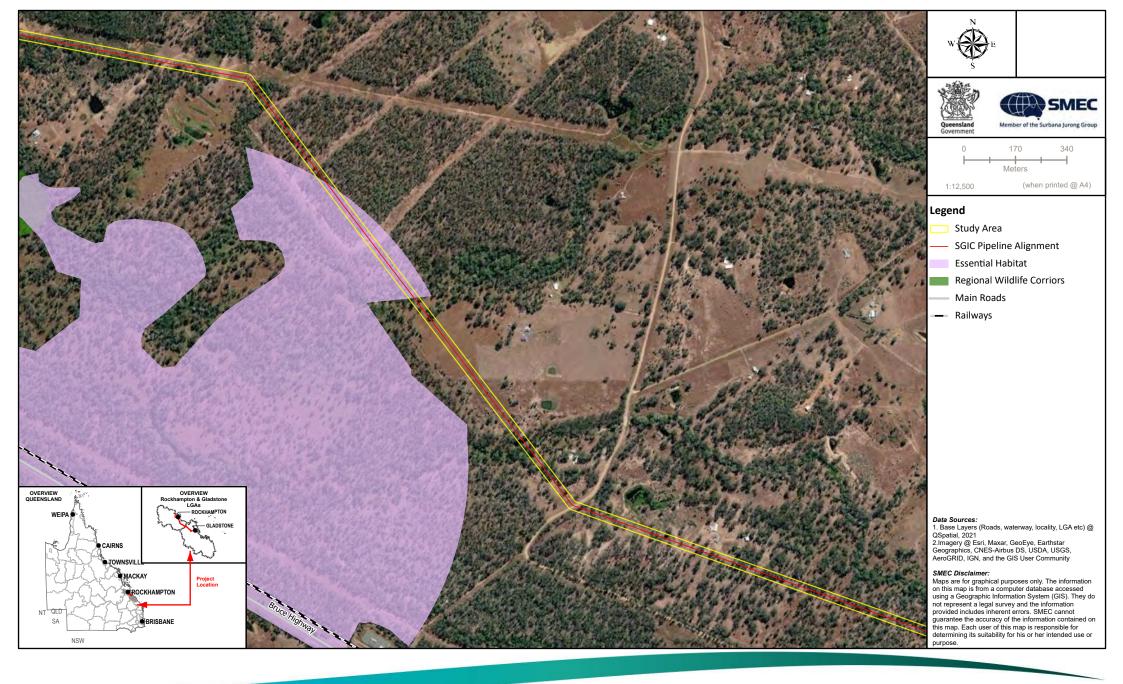
Fitzroy to Gladstone Pipeline Baseline Terrestrial and Aquatic Ecology Technical Report Figure 4-5a Essential Habitat and Wildlife Corridors Within the SGIC SDA Desktop Search Extent 000-G-MAP-2414 Version:3 Date:2022/09/19

The SGIC SDA pipeline alignment intersects multiple areas of mapped essential habitat for conservation significant species listed under the NC Act as shown in Figure 4-5. These areas include essential habitat for the curlew sandpiper (*Calidris ferruginea*), lesser sand plover (*Charadrius mongolus*), ornamental snake (*Denisonia maculata*), yellow chat (Dawson) (*Epthianura crocea macgregori*), squatter pigeon (southern) (*Geophaps scripta scripta*), Australian painted snipe (*Rostratula australis*), powerful owl (*Ninox strenua*) and koala (*Phascolarctos cinereus*).
